Structural Tests of Mechanical Connections For Concrete Panels

L. E. Cattaneo and F. Y. Yokel

Final Report

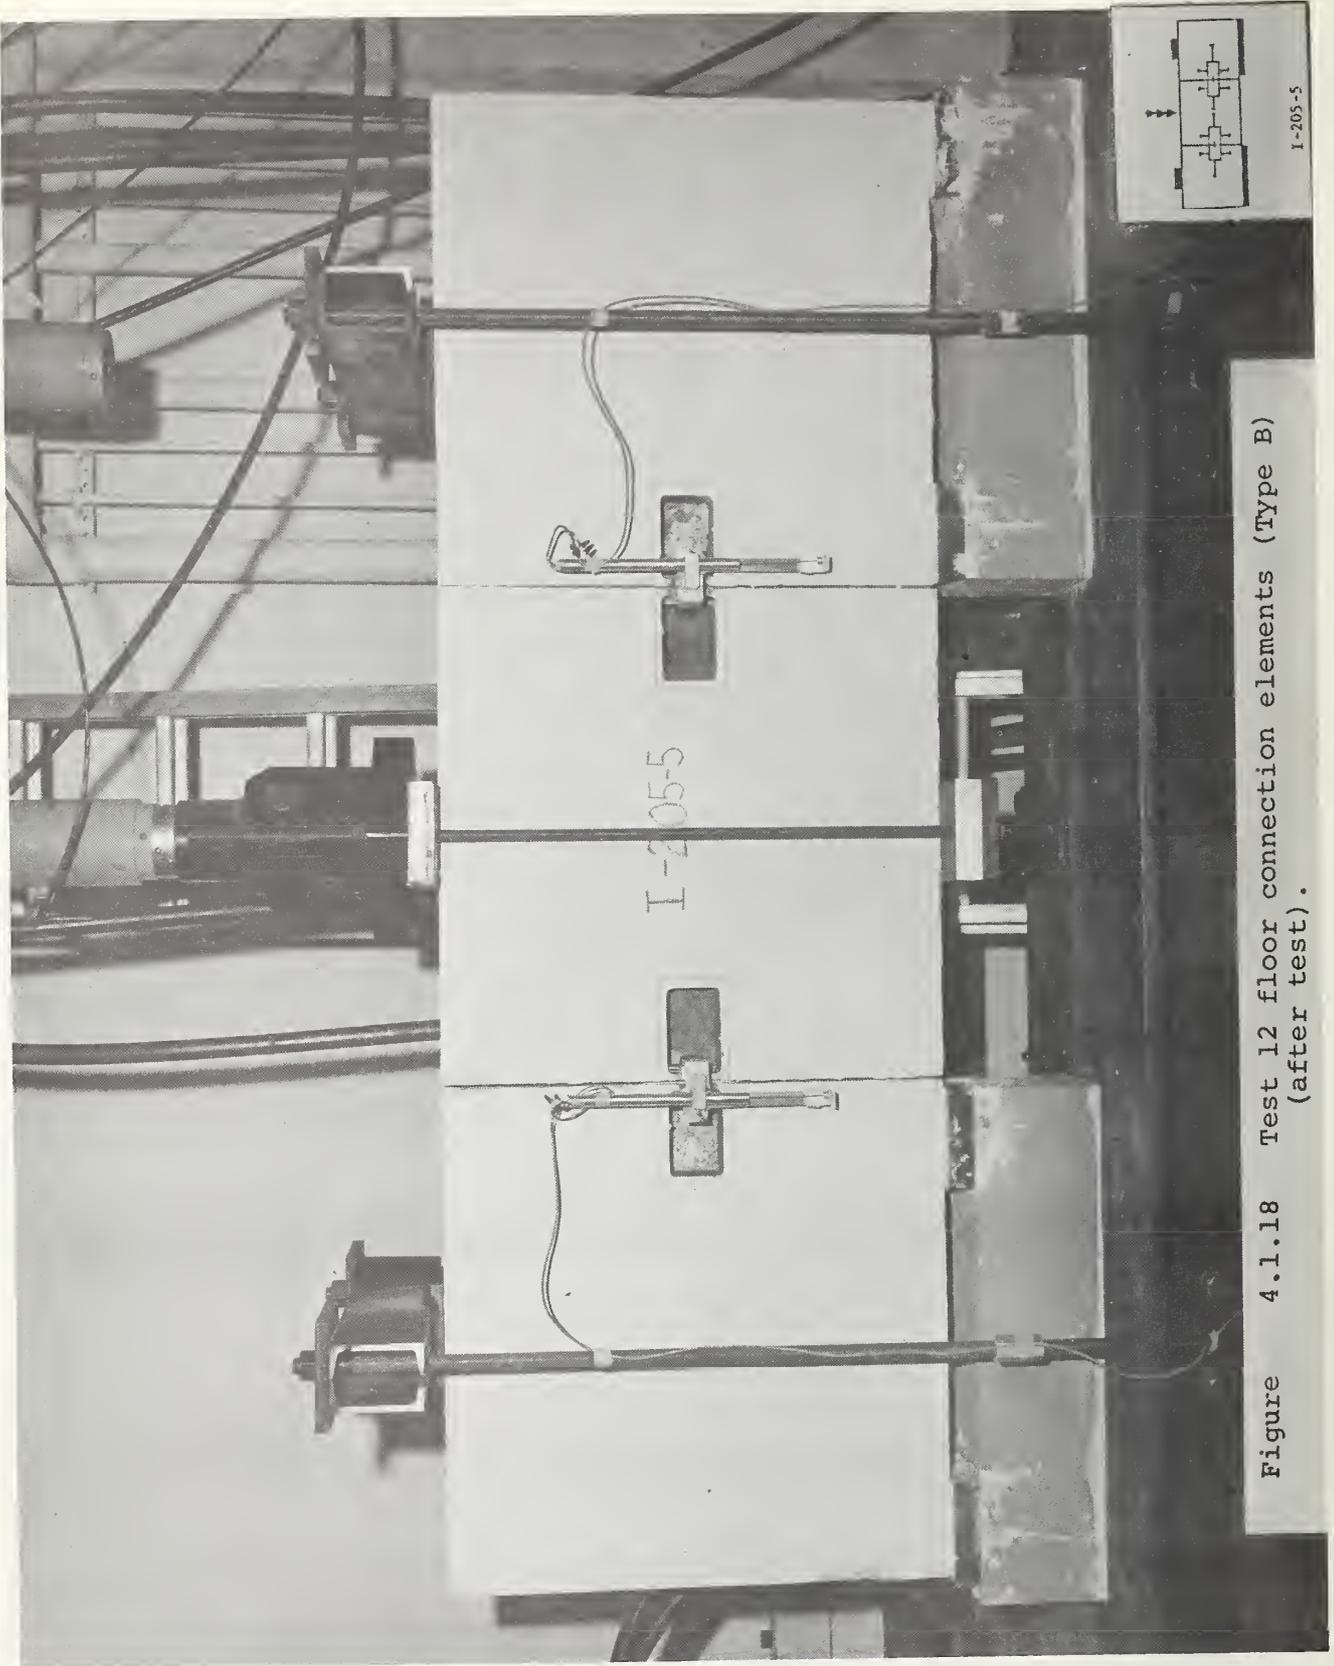
Figure 4.1.18 Test 12 floor connection elements (Type B)
(after test).

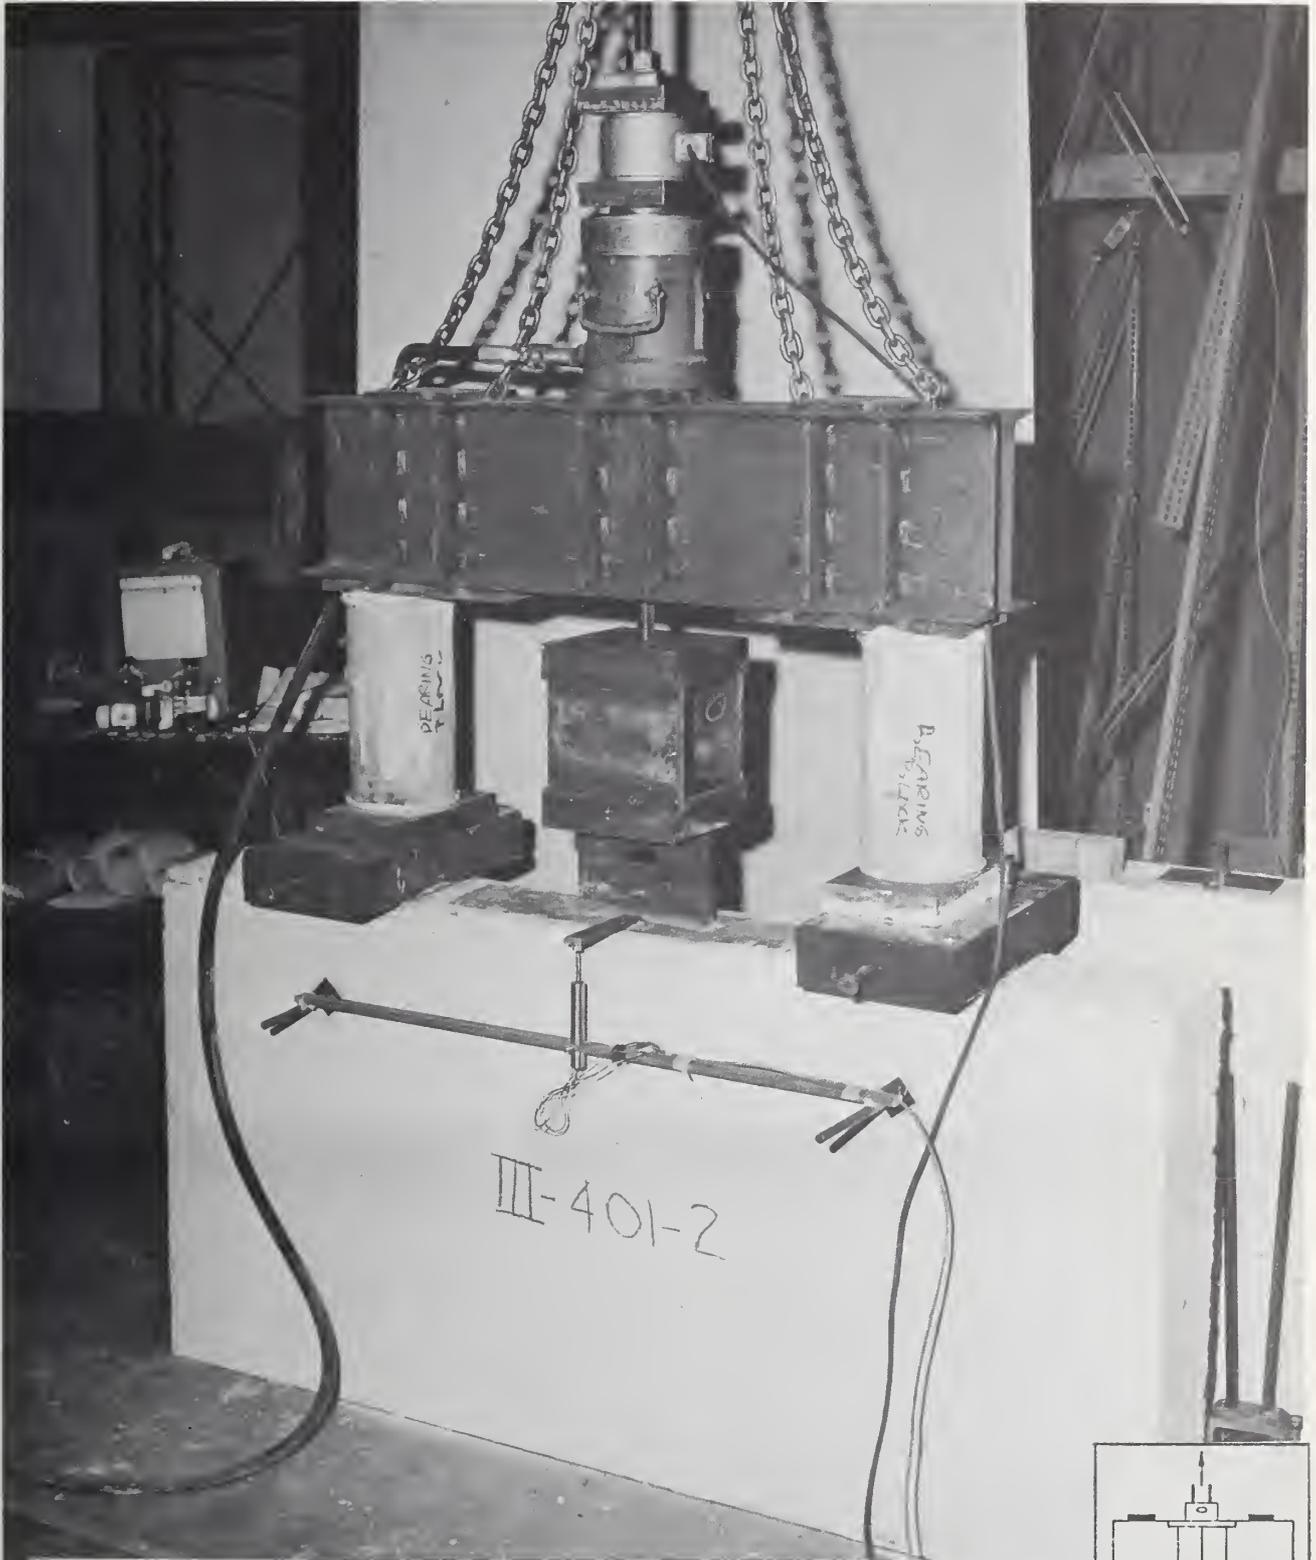
Three identical specimens were tested under similar loading conditions in Tests 14, 15, and 16. Figure 4.2.1 shows the setup for Test 14. Tension was applied through nuts attached to the high strength stud bolts . Displacements were measured between the concrete panel and the base plate of the connector. Displacements observed in this test were very small and failure occurred by rupture of the bolts (fig. 4.2.2). In subsequent tests, displacement measurements were made of bolt elongation (as shown in fig. 4.2.3 for Test 15). Figure 4.2.4 shows the results of Test 15 and figure 4.2.5 shows the setup for Test 16 in which both displacement of base plate and bolt elongation were measured. The failure in Test 16 is shown in figure 4.2.6. Typical measurements are plotted in figures 4.2.7 and 4.2.8 for bolt elongation in Test 16; and in figures 4.2.9 and 4.2.10 for base plate displacement in the same test. The connection elements in all three tests developed tensile load capacities ranging from 55 kip to 58 kip. In all three, failure by fracture occurred with very little elongation of the high strength bolts (approximately 0.04 in). In establishing allowable design loads for these connection elements allowance should be made for their lack of ductility.

Figure 4.2.1 Front of Test 14 wall top connection element (Type E) (before test).

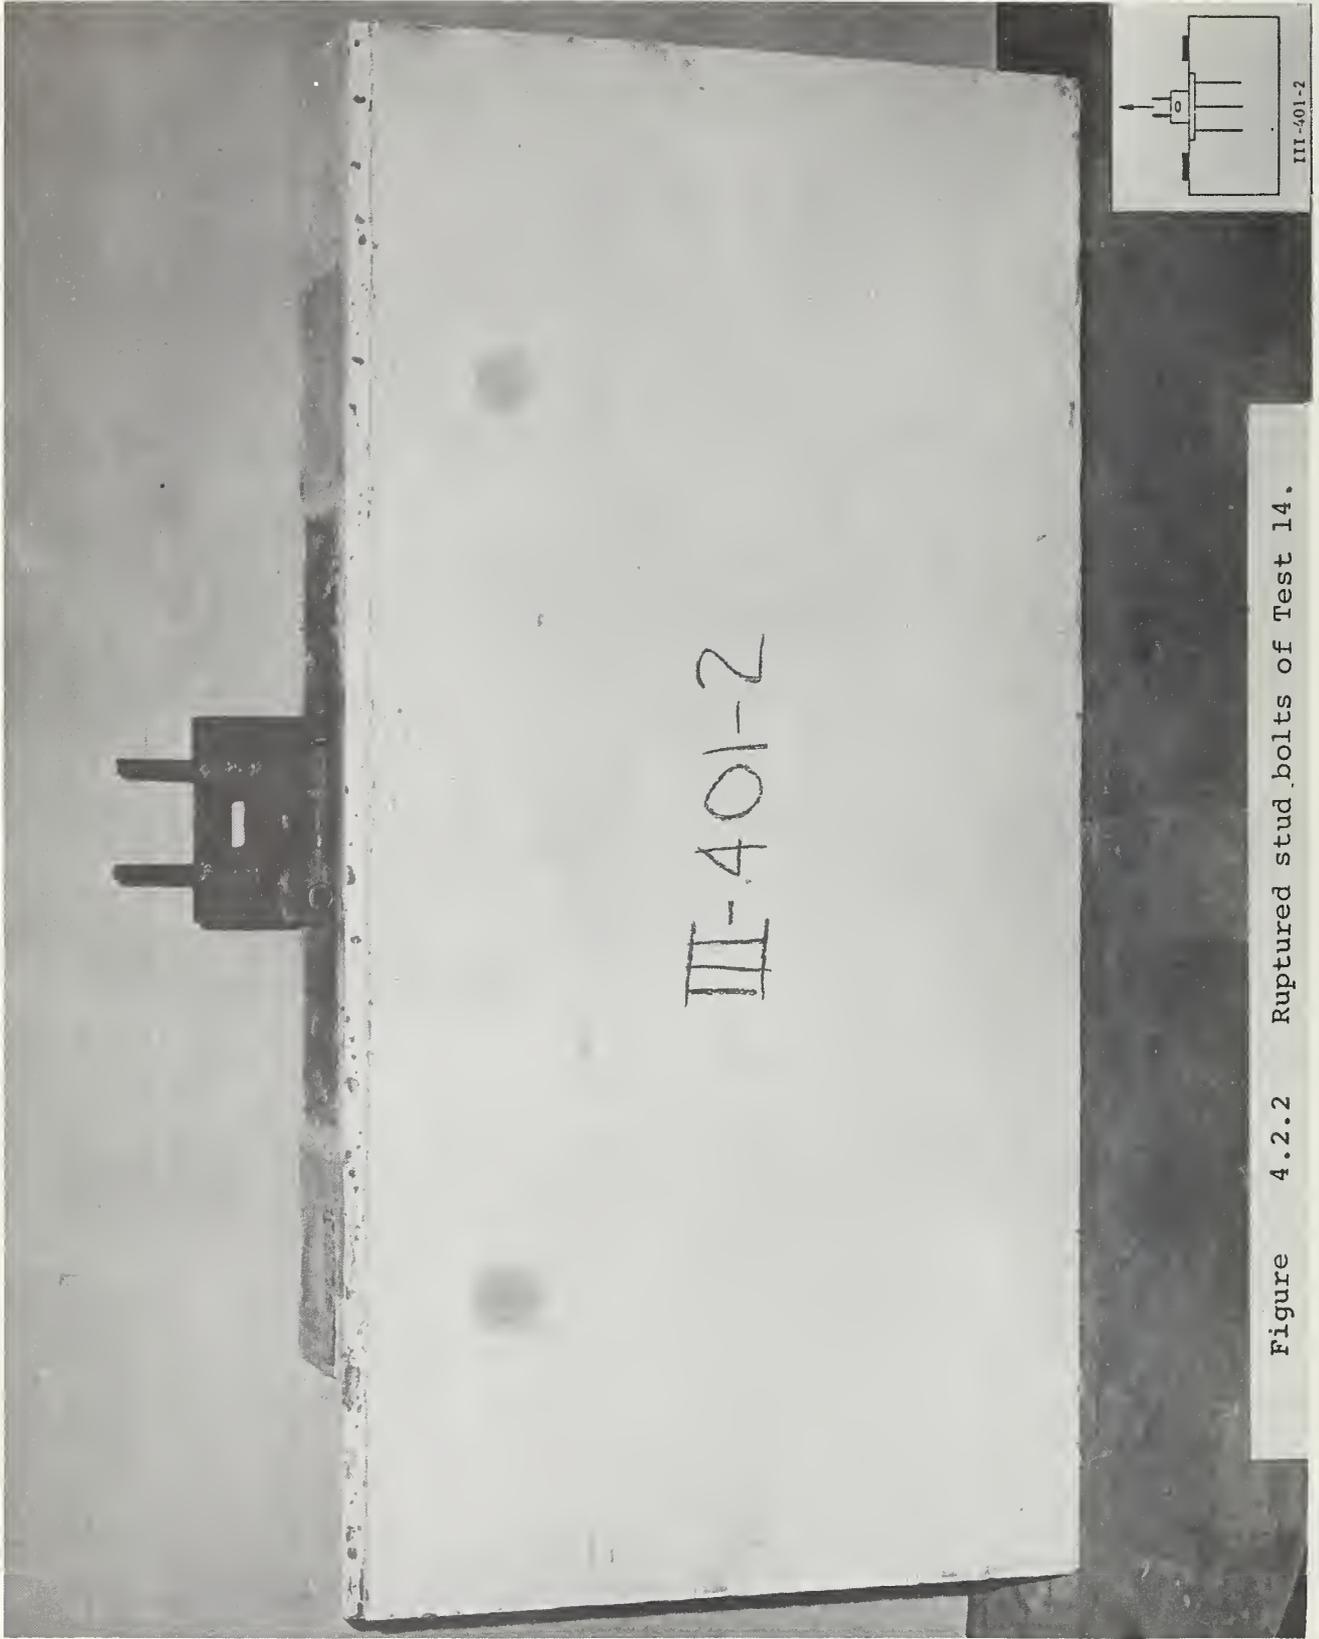
Figure 4.2.2 Ruptured stud bolts of Test 14.

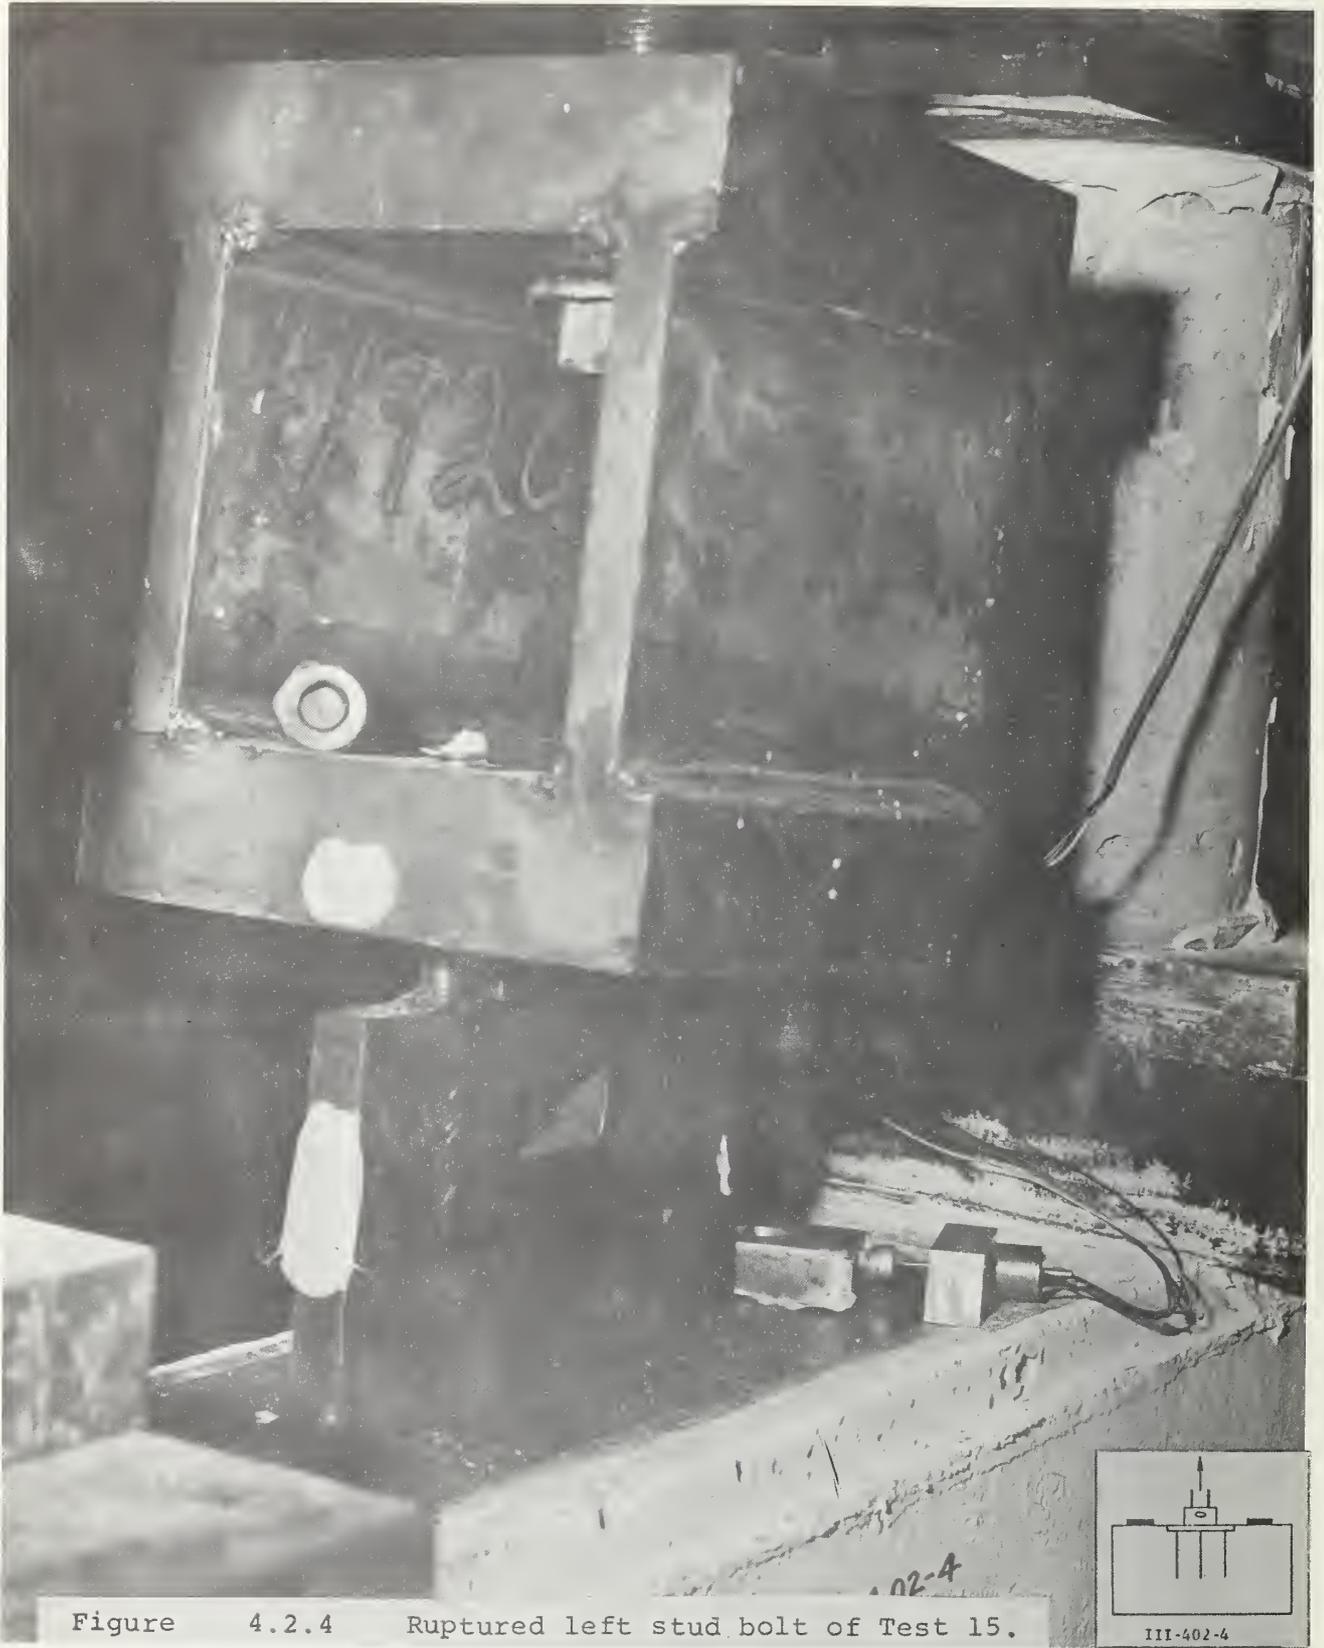
Figure 4.2.4 Ruptured left stud bolt of Test 15.

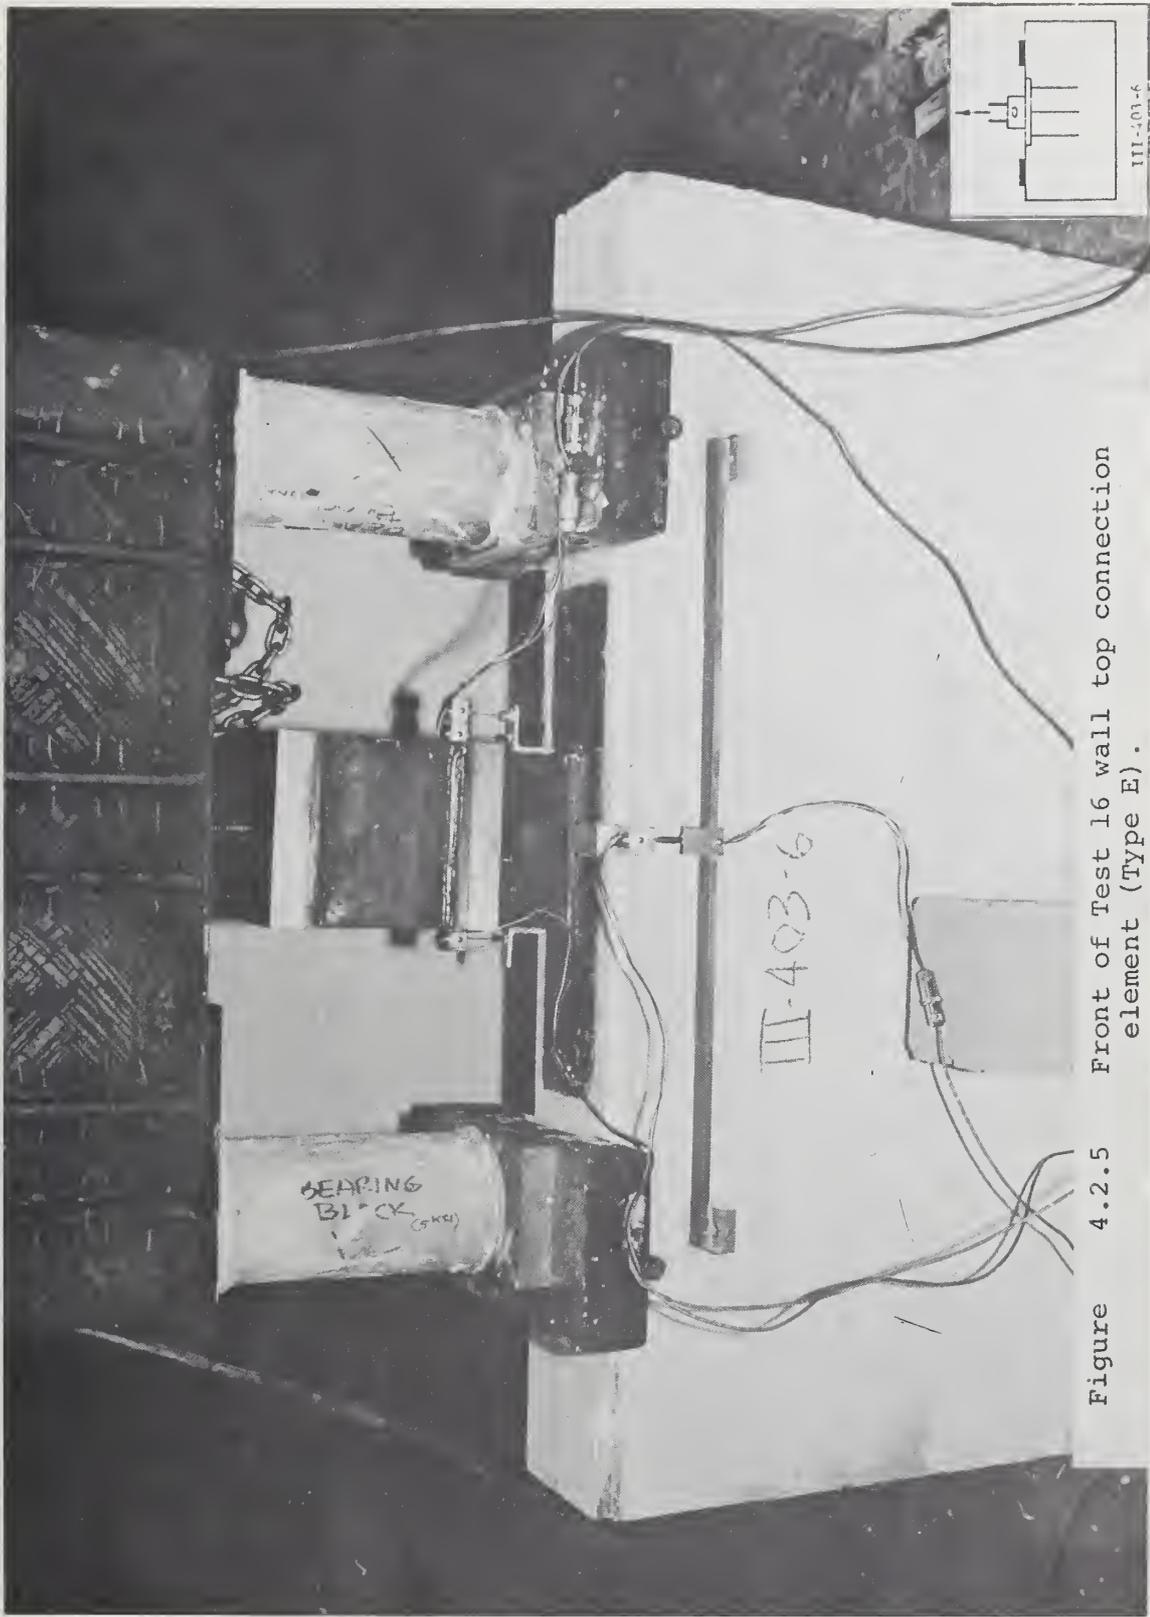
Figure 4.2.5 Front of Test 16 wall top connection element (Type E).

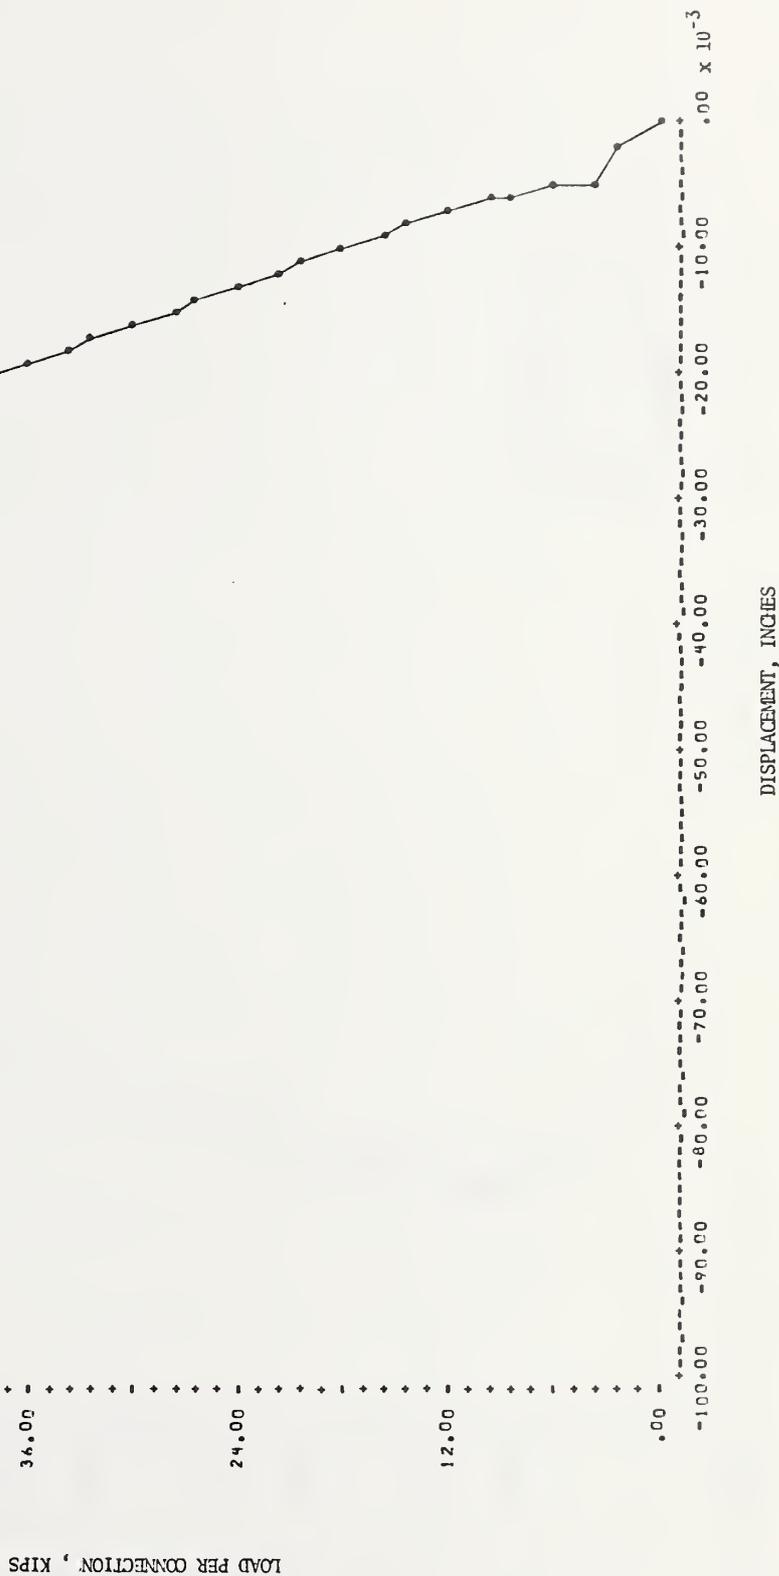
PLOT OF INSTRUMENT 5 LOAD IN KIPS
VS. INSTRUMENT 1 LVDT NORTH .001 IN

Figure 4.2.7 Elongation of right stud bolt in Test 16.

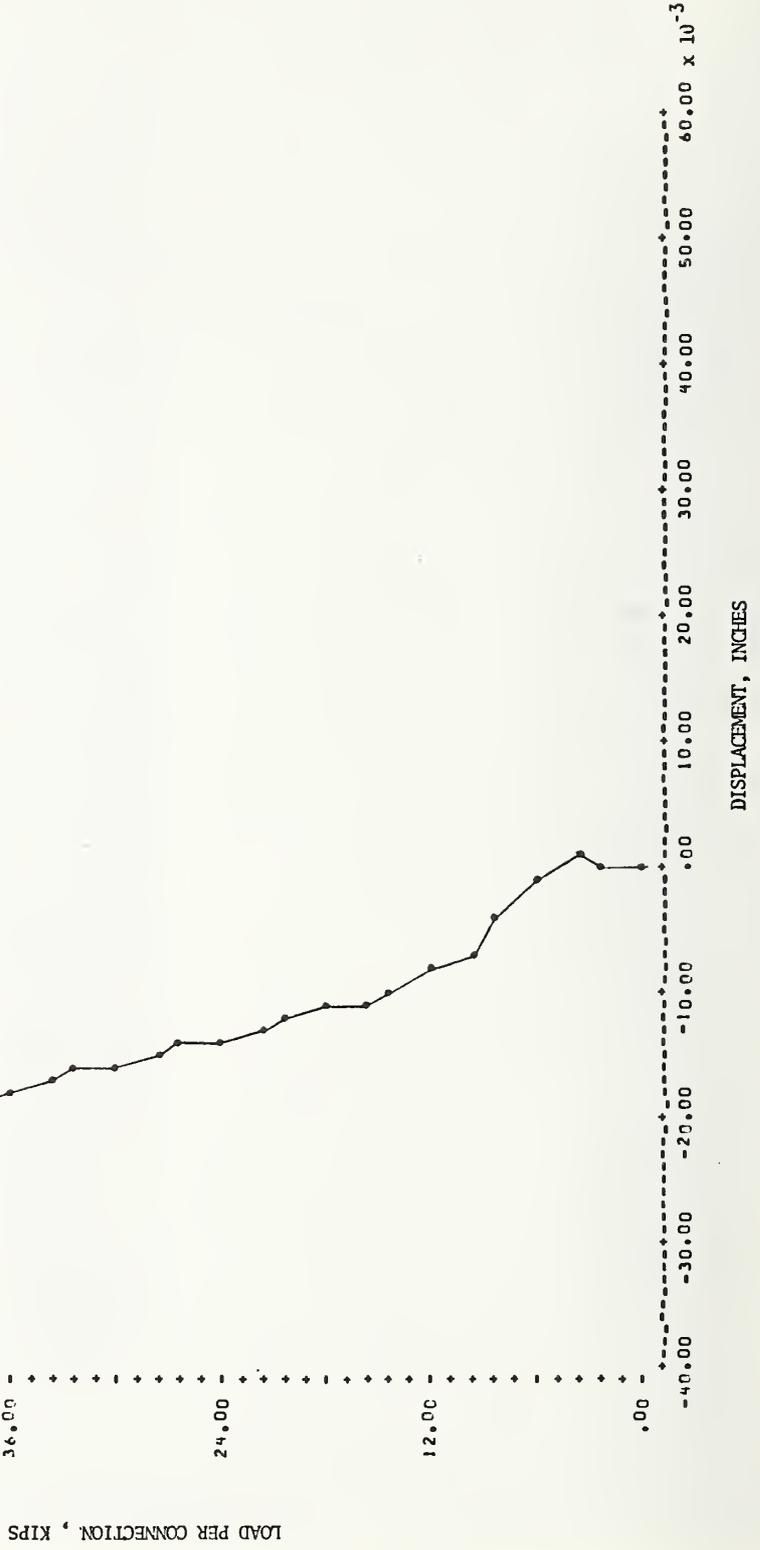
PLOT OF INSTRUMENT 5 LOAD IN KIPS
VS. INSTRUMENT 2 (VDVT SOUTH) .001 IN

Figure 4.2.8 Elongation of left stud bolt in Test 16.

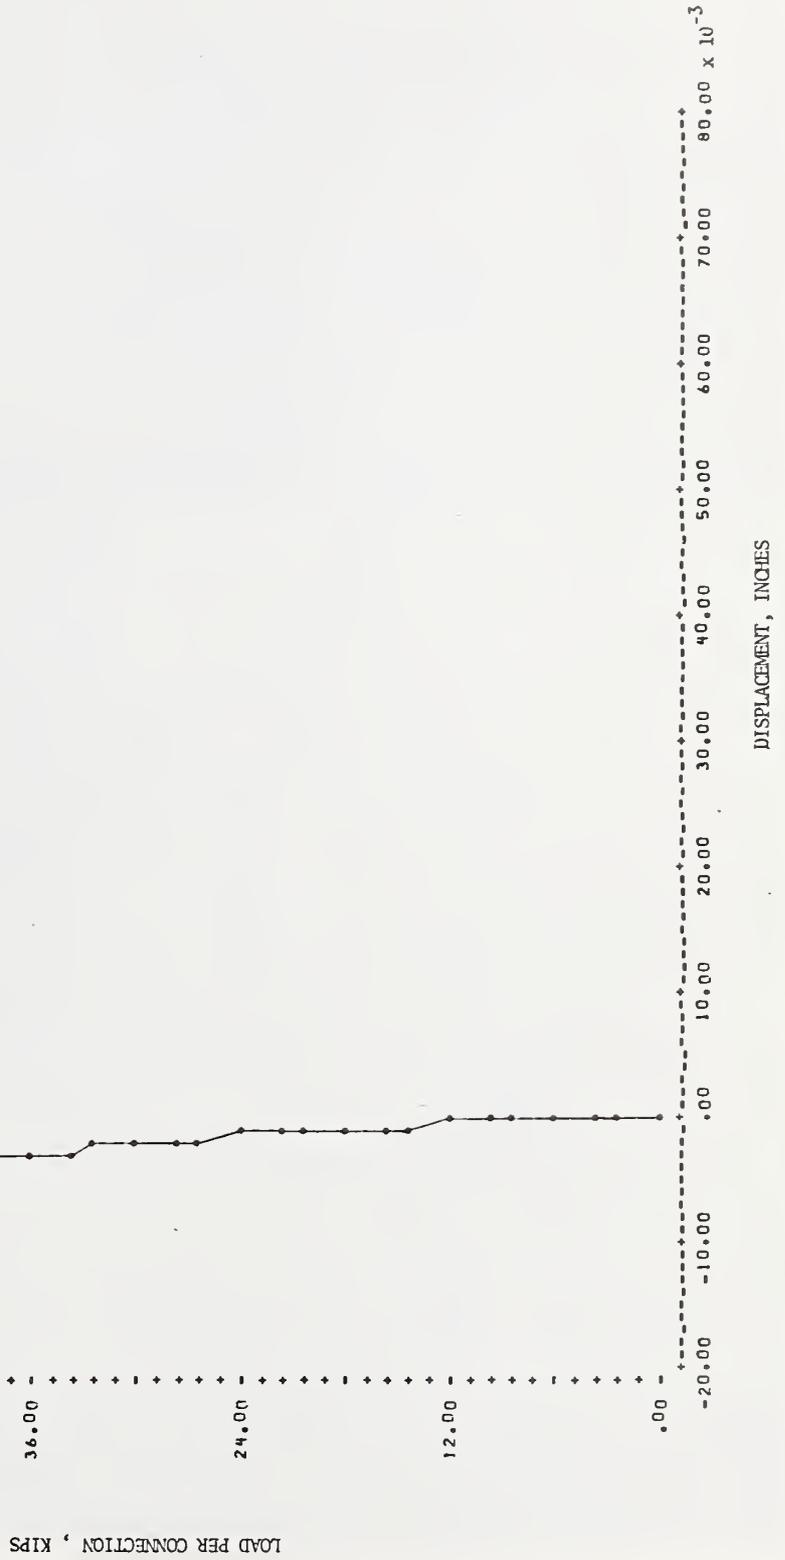
PLOT OF INSTRUMENT 5 LOAD IN KIPS
VS. INSTRUMENT 3 LVDT EAST .001 IN

Figure 4.2.9 Uplift of front edge of base plate in Test 16.

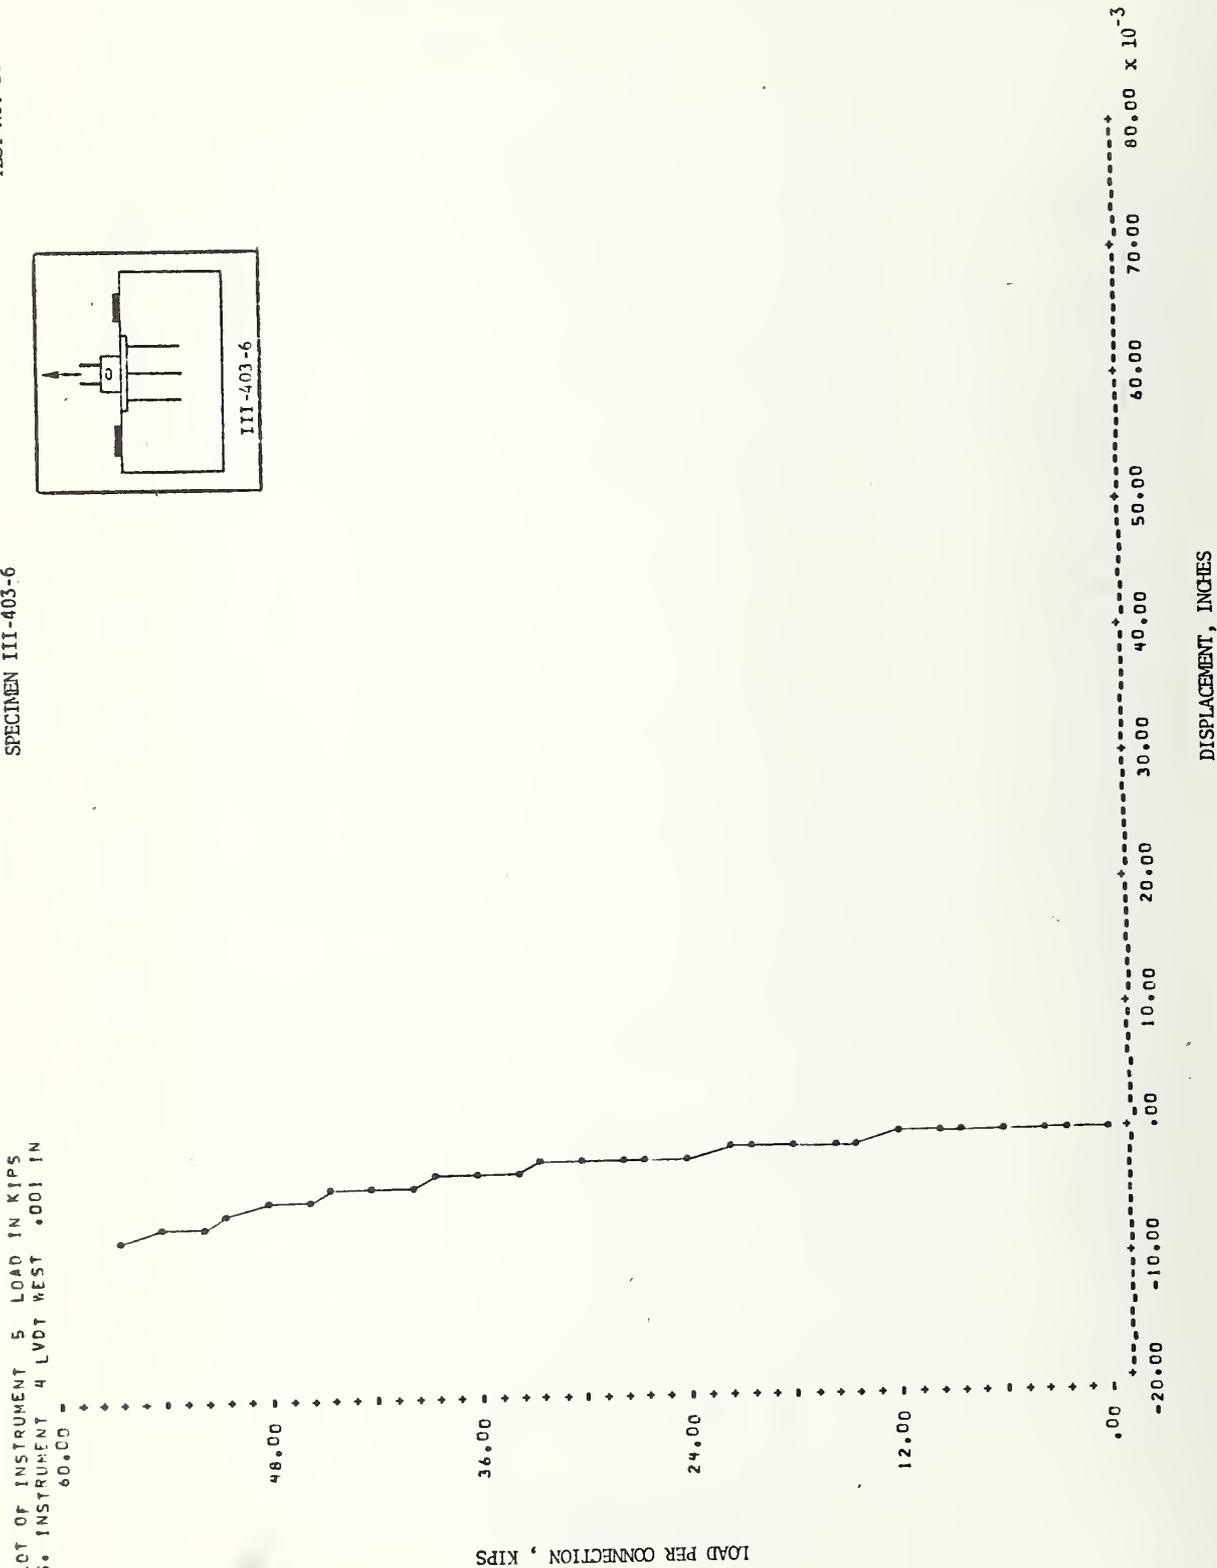
PLOT OF INSTRUMENT 5 LOAD IN KIPS
VS. INSTRUMENT 4 LVDT WEST .001 IN

Figure 4.2.10 Uplift of rear edge of base plate in Test 16.

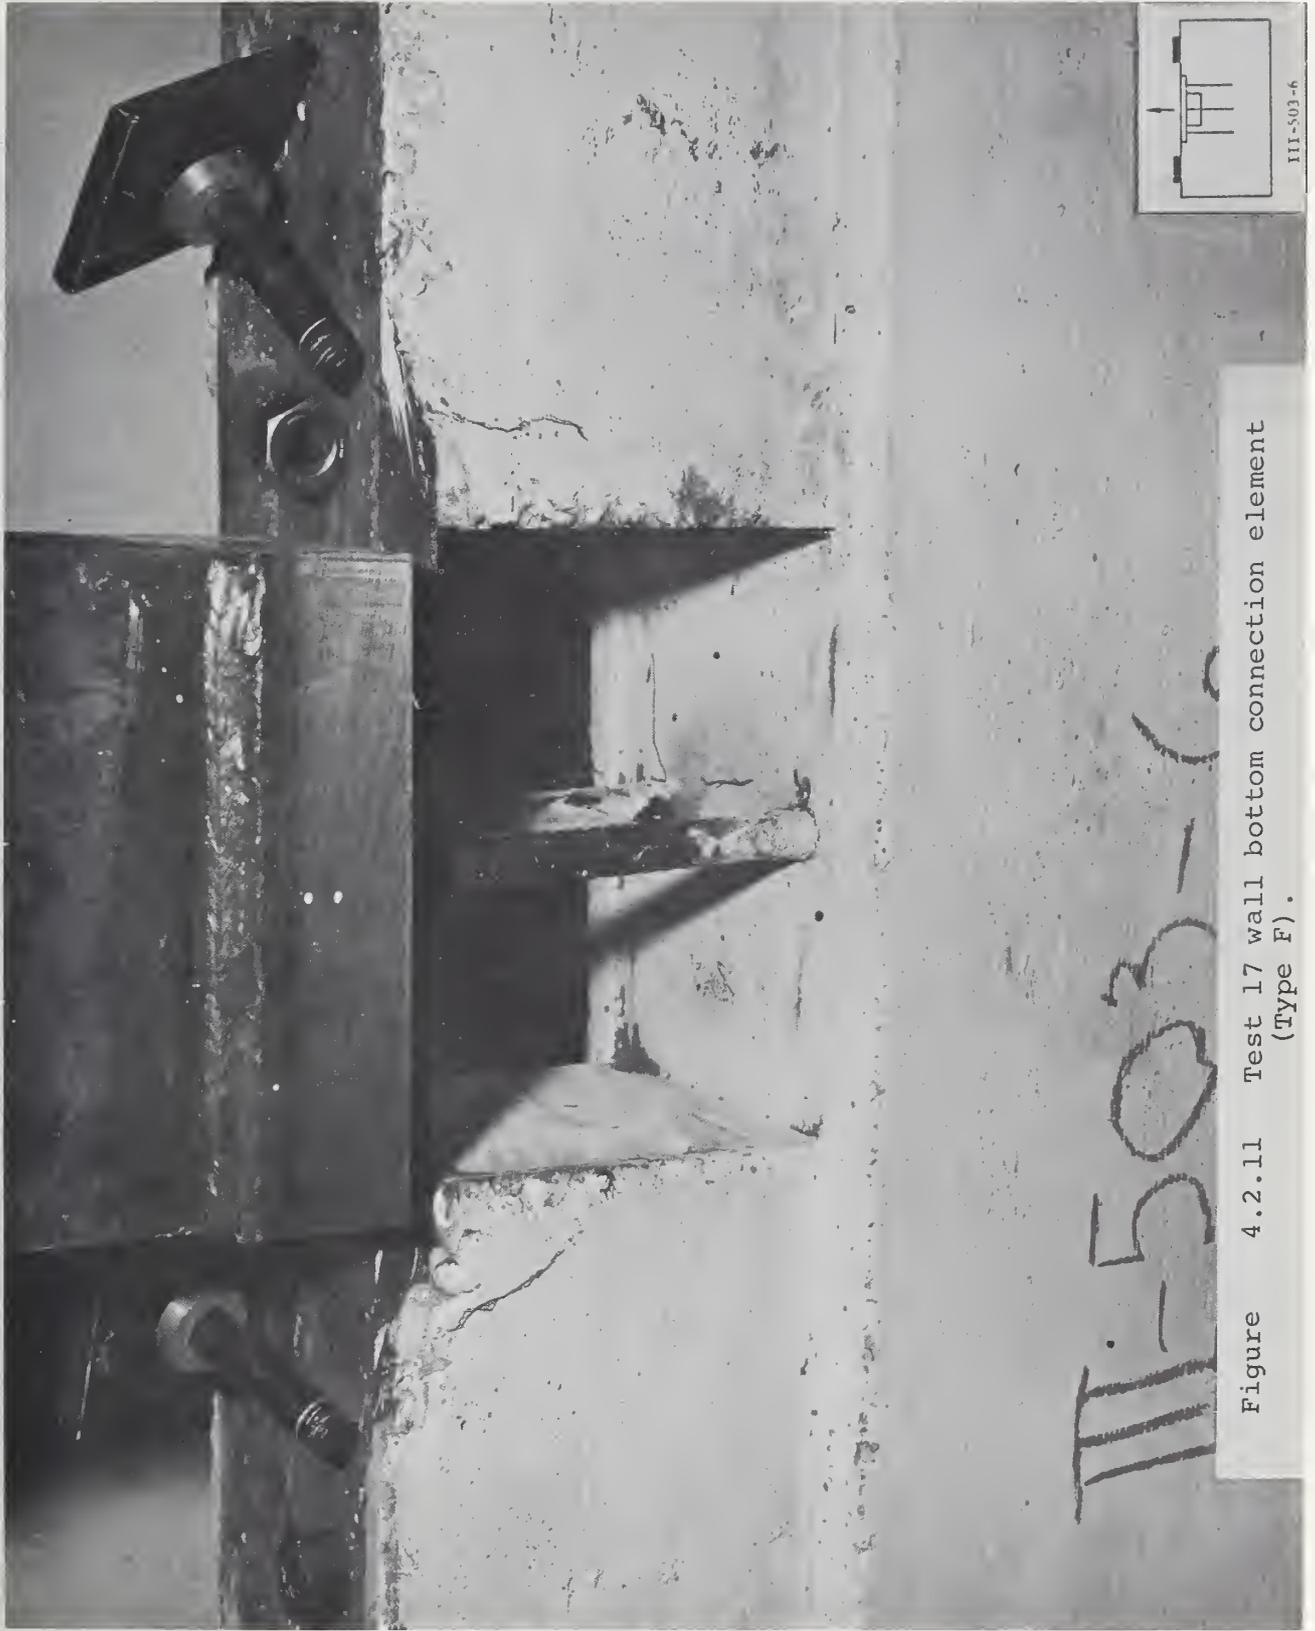
Type F elements connect to Type E elements and therefore fulfill the same function in tension. Thus the capacity of the connection in tension must be controlled by the weaker of the two elements. Three tests were performed. In Test 17 (fig. 4.2.11) the connection element was not grouted. In Tests 18 and 19 (figs. 4.2.12 and 4.2.13) similar grouted specimens were used. In all cases failure occurred in the connecting bolts which actually simulated the mating bolts of a Type E element. Except for minor concrete cracking no other distress was observed. The lowest load capacity was observed in Test 17 where failure was caused by thread stripping in both nuts (fig. 4.2.11). Unless design provisions are made to prevent thread failure, the lower load capacity in this test controls the allowable tensile load on the joint composed of Types E and F elements.

Figure 4.2.11 Test 17 wall bottom connection element
(Type F).

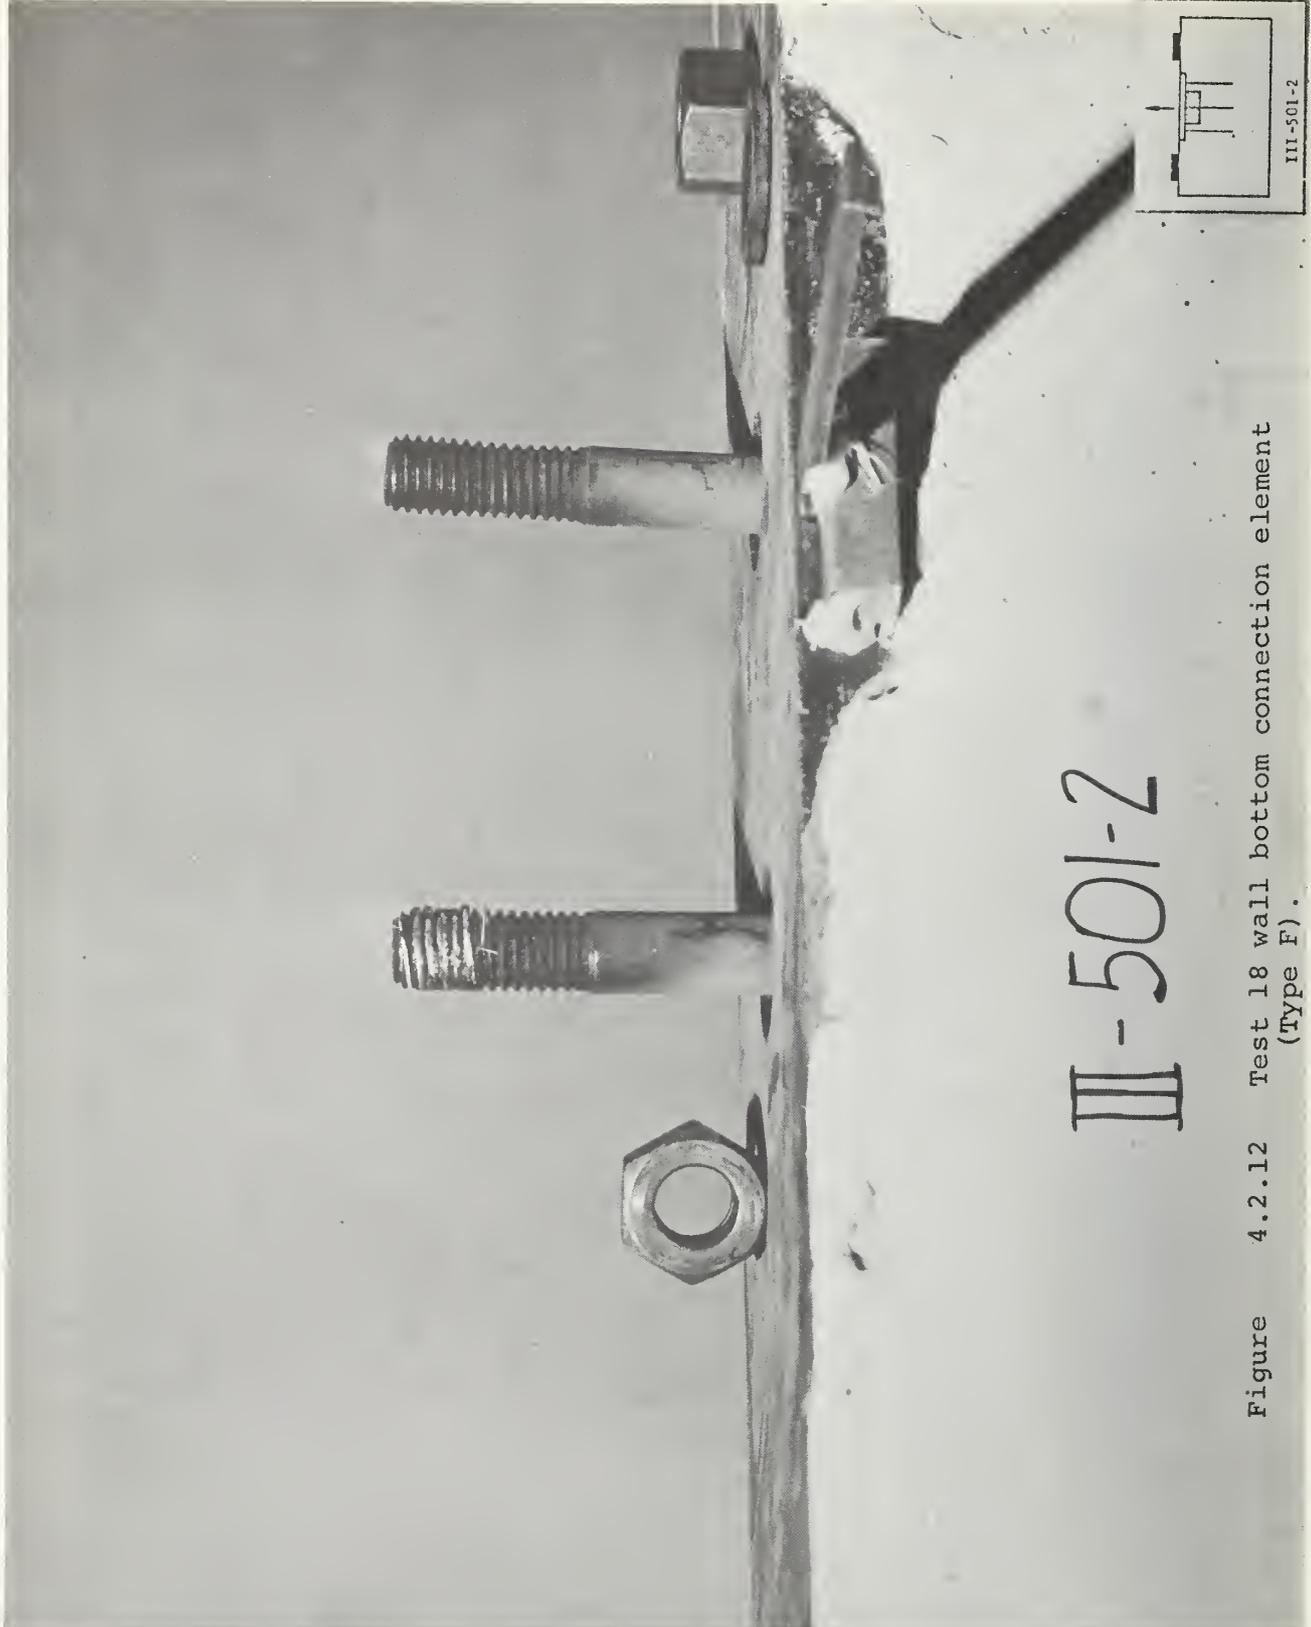
Figure 4.2.12 Test 18 wall bottom connection element (Type F).

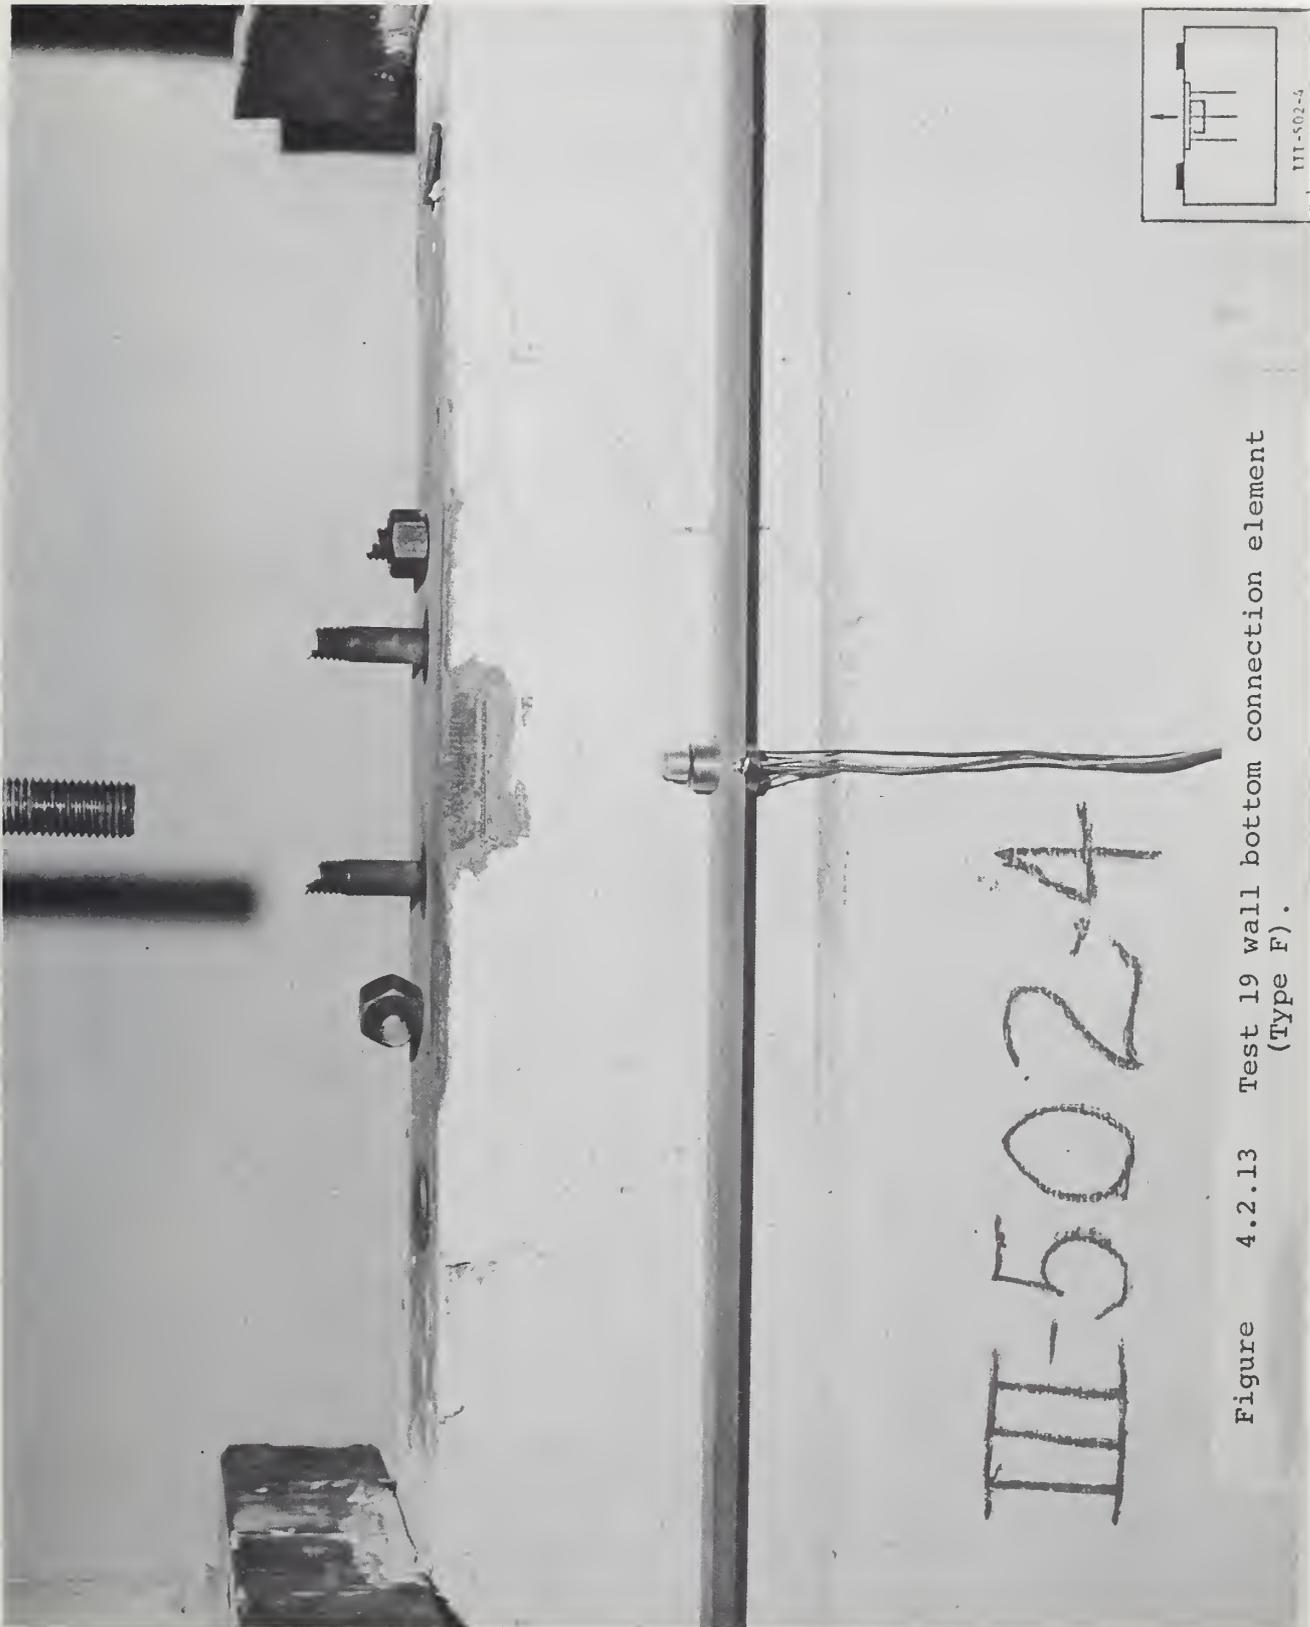
Figure 4.2.13 Test 19 wall bottom connection element
(Type F).
